# Protective shields solve condenser inlet-end erosion/corrosion problem

By Bill Stroman, Aptech Engineering Services Inc

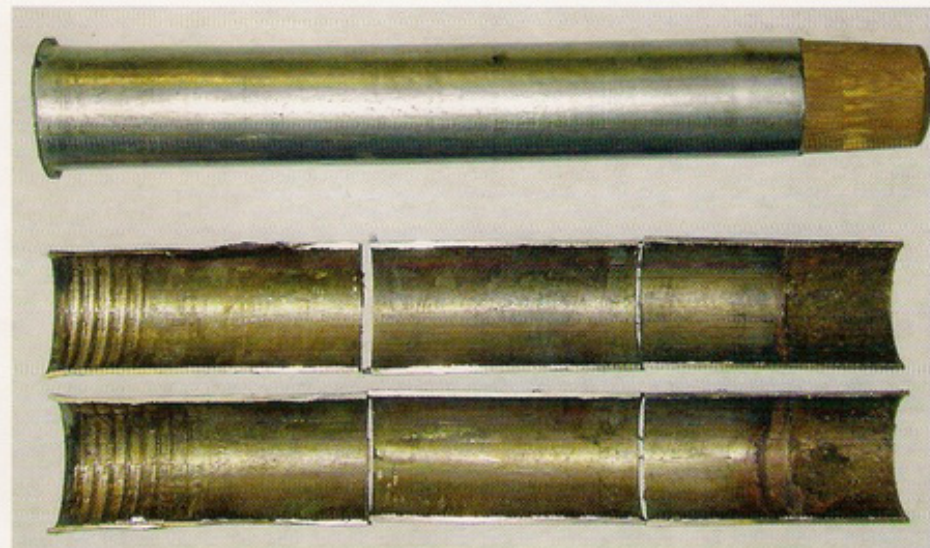
1. Condenser tube inlet where the AL6X shield had been installed is at the bottom. Note that the wooden plug could not be removed from the insert when it was extracted from the tube (top of photo)

This failure investigation offered the opportunity to review the 22-year performance history of the tube inserts. Inspection of the tube section that contained the sleeve insert confirmed that the sleeves were continuing to perform as intended (Fig 1). One of the concerns of the inspection team was the performance of the new cathodic protection system installed four years earlier. They found no evidence of erosion or corrosion at the exit end of the shield, where the potential for galvanic corrosion is highest (Fig 2).

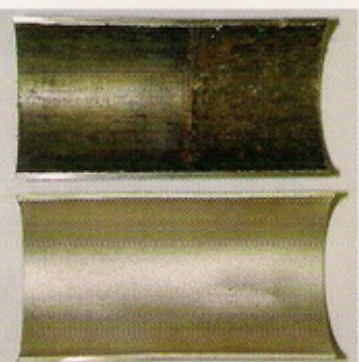
2. Tube inlet surface with shield removed shows oxide downstream of where the shield ended (top). After abrasive blast cleaning (bottom), tube shows no evidence of exit-end corrosion after 22 years
